Docket No. 217 – Development and Management Plan Inspection

Northeast Utilities Service Company Certificate of Environmental Compatibility and Public Need for the construction of a 345-kV electric transmission line and reconstruction of an existing 115-kV electric transmission line between Connecticut Light and Power Company's Plumtree Substation in Bethel, through the towns of Redding, Weston, and Wilton, and to the Norwalk Substation in Norwalk, Connecticut.

Date: September 29, 2006

Location: Transition Stations: Hoyts Hill, Archers Lane, Norwalk Junction

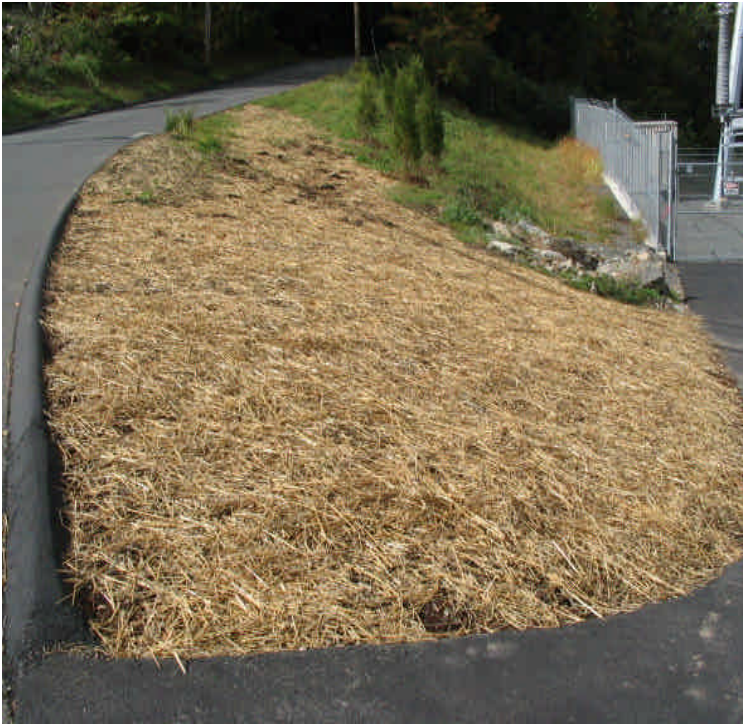
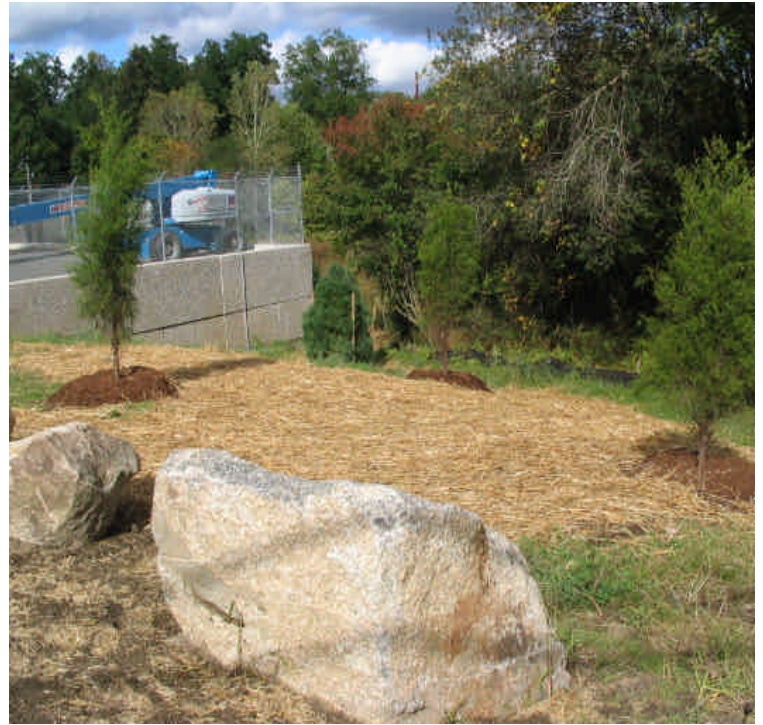
Hoyts Hill Transition Station: Photo on the left shows the asphalt curbing that was recently installed. The adjacent slope has also been restored and mulched. Photo on the right shows restoration, mulch and landscaping along the southern slope. 9/29/06

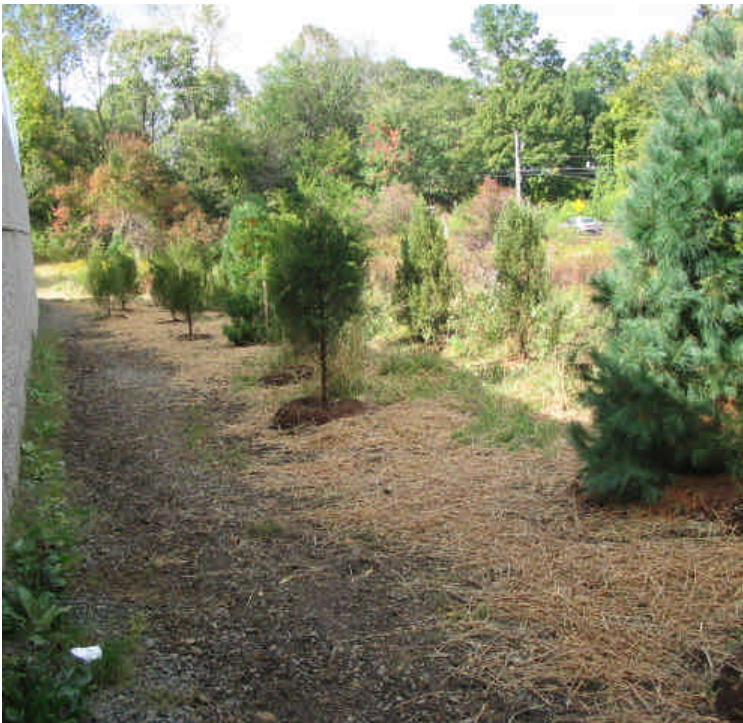
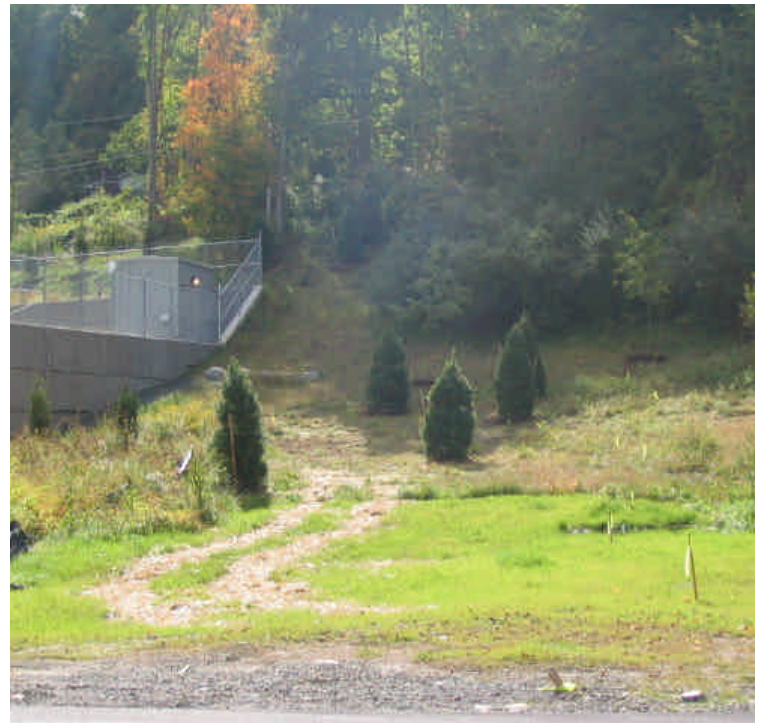
Photo on the left shows the landscaping along the edge of the wetland below the retaining wall. Photo on the right shows another view of the landscaping from Rt 58. Tire tracks in the wetland area were restored and mulched. 9/29/06

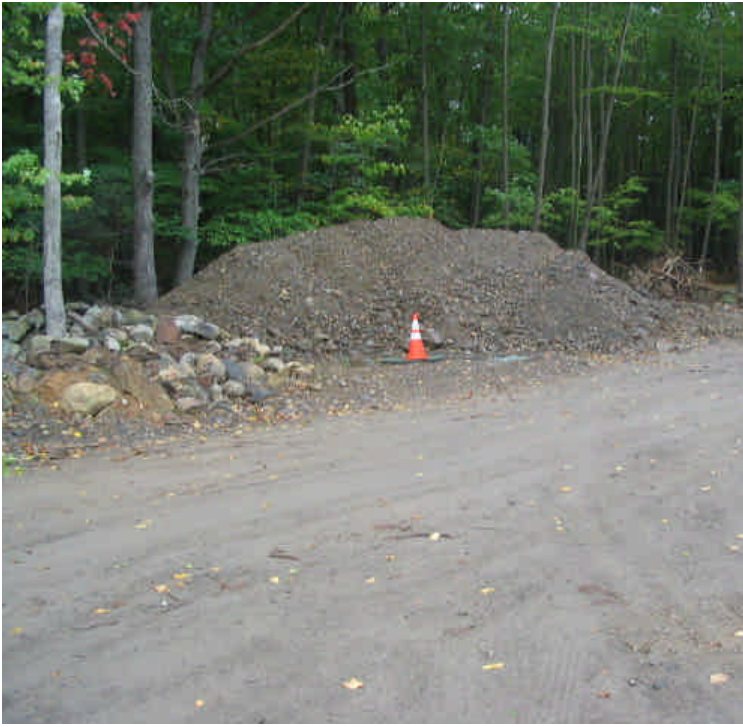
- Accumulated sediment had been removed from the wetland by hand appropriately. 9/29/06	- Continue to monitor and prevent future sedimentation. 9/29/06	The wetland is in good shape.
	-Slopes remain disturbed along the access road where 345kV trenching	- AL contractors will likely need to perform restoration when work is	- Needs attention when work is complete

Archers Lane: Photo on the left shows some remaining stockpiles and bare slopes along the access drive. These areas should be restored/vegetated to the extent feasible. Photo on the right shows an overview of the yard. The line and stations will be energized soon. 9/29/06

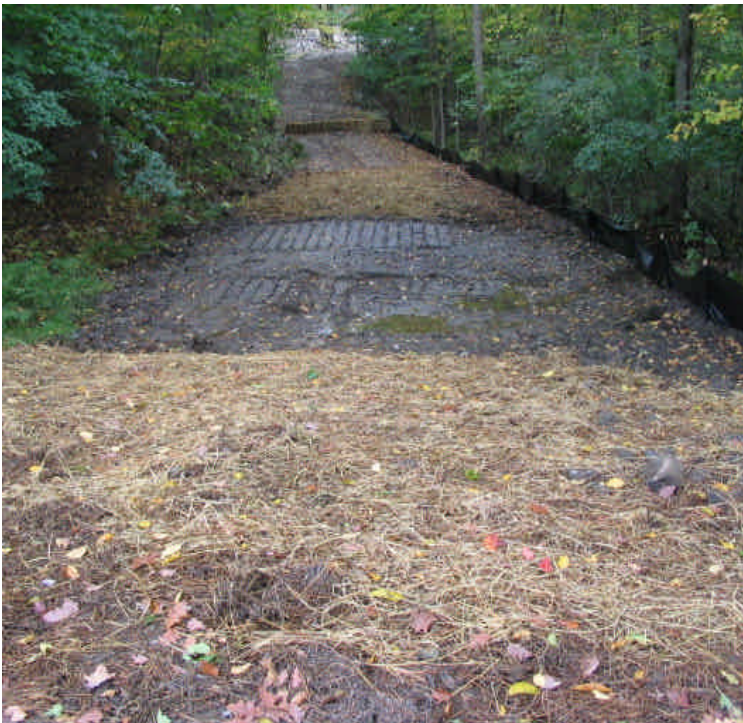
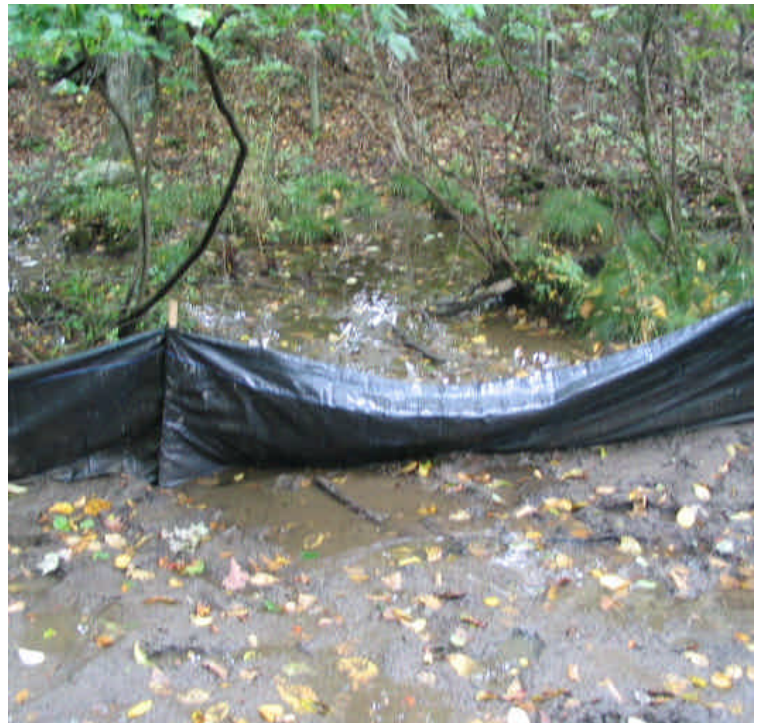
Photo on the left shows the 1st wetland crossing fully restored with timber mats recently removed. The area is well restored and graded back to original conditions. Photo on the right shows where sediment was removed from the wetland. Silt fence continues to filter surface flow. 9/29/06

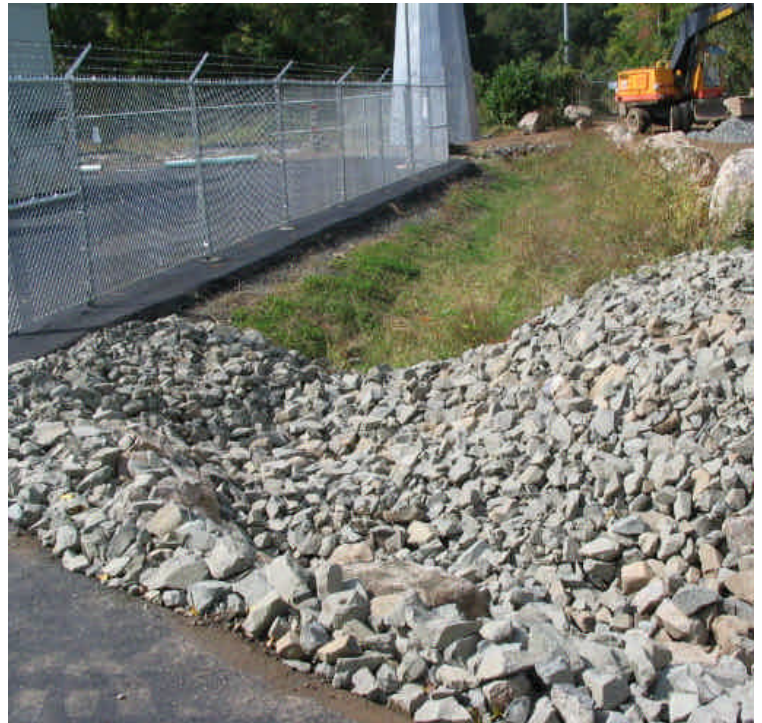
<p>-The swale was well restored and reinforced with stone at the driveway crossing. New haybales were installed at the first culvert 9/29/06 The remainder of the swale remains as exposed soil 8/16-9/29/06</p>	<p>-Revegetate/ stabilize the remaining swale if feasible. 8/16-9/29/06</p>	<p>- The swale was reinforced and still needs some final stabilization</p>
Inland Wetland and Watercourse encroachment and mitigation	<p>- Hoyts Hill: The wetland remains well protected and well vegetated. Adjacent landscaping was complete. 9/29/06</p> <p>-Archers Lane: Restoration at the 1st wetland crossing is complete and adjacent areas are restored. 9/29/06.</p> <p>- Norwalk Junction: The</p>	<p>-Erosion controls could likely be removed from most areas. 9/29/06.</p> <p>- Continue to monitor for final stabilization. 9/29/06.</p> <p>- Reduce turbidity by</p>	<p>- N/A.</p> <p>-Restoration is complete</p> <p>-Needs attention</p>

Norwalk Junction: Photo on the left shows the view of the paved station yard and driveway with the perimeter fence in place. Photo on the right shows the reinforced area of the swale at the driveway crossing. 9/22/06.

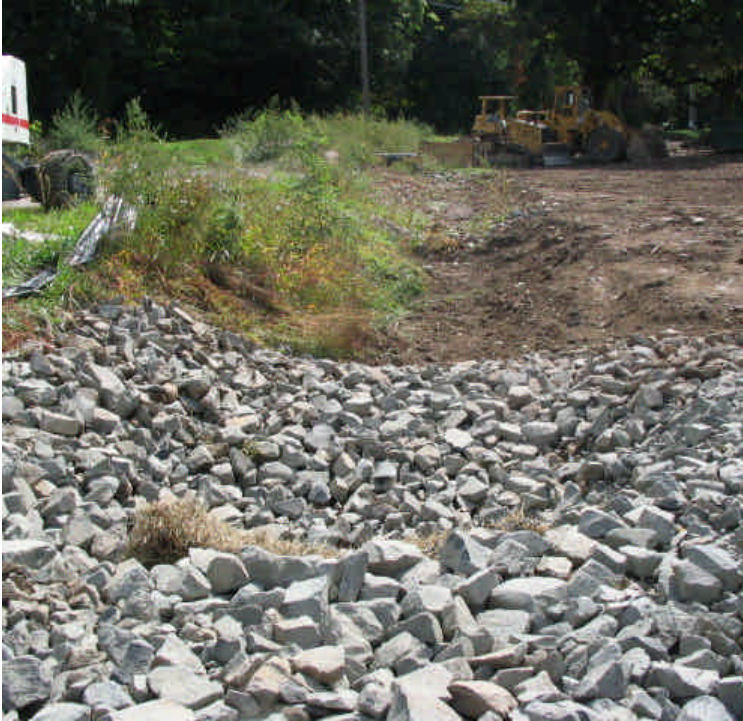
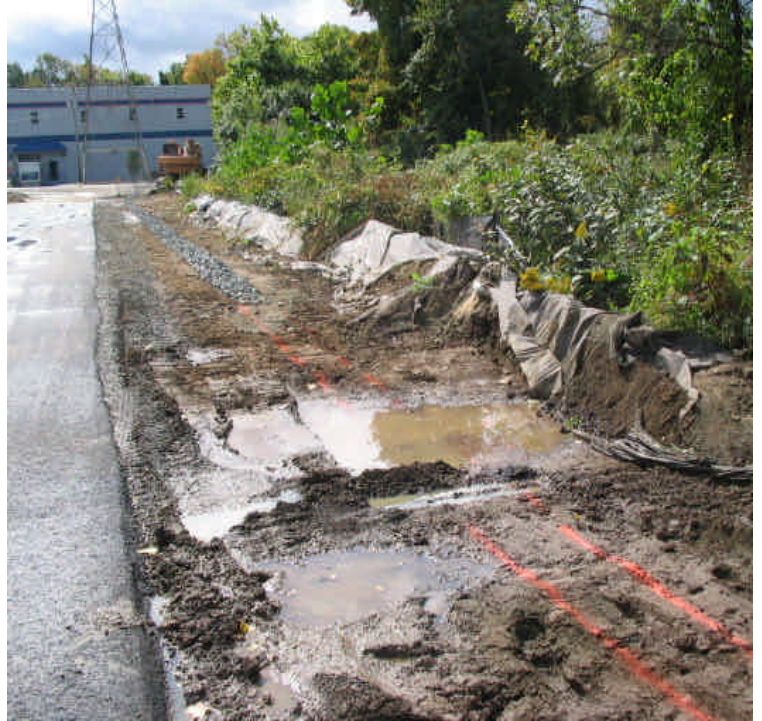
- Norwalk Junction: Perimeter silt fence remain in good shape along the river. 5/17-9/29/06. The adjacent, non-project related berm is degrading and presents a potential	- None at this time. Continue to monitor controls. 5/17-9/29/06. - If feasible, work with adjacent landowner to determine final	-N/A -Needs evaluation if feasible (not technically project

Photo on the left shows the reinforced area of the swale looking towards Rt 7. Adjacent areas still need vegetation/restoration. Photo on the right shows the paved area adjacent to the yard. The disturbed soil surface should be vegetated to the extent feasible and the non-project related berm is degrading. 9/29/06.
